## West Coast – Tower Collapse... take 2!

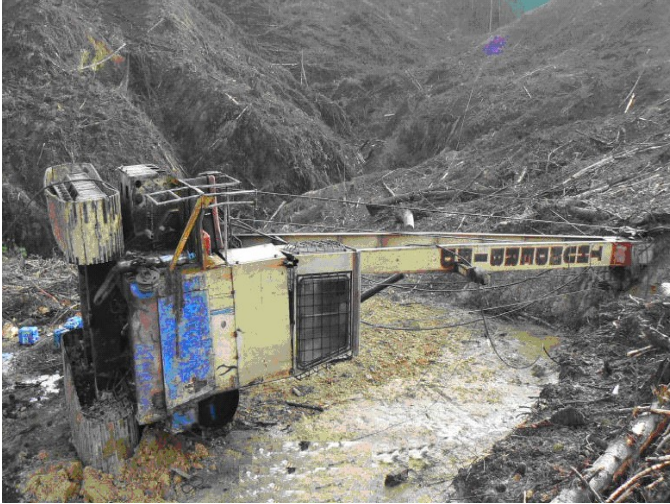
During hauling, a stem nose-dived into the gully and buried itself. The 'extension' on the main support guy-line, unable to bear the additional loading, broke. The shock loading placed on the secondary guy caused its stump to shear off, and the tower toppled.

- This topple-over occurred in September following a very similar event that occurred in May 2009 at which time, the investigating team concluded that the **poor condition of the extension guy** was the single major cause for the topple-over.
- After the May topple all hauler crews were visited and their set-ups inspected – this involved **checking all of the guys and extensions at each site**. At this time no concerns regarding the condition of any of the ropes or extensions were recorded.
- The inspections were carried out on those ropes which were either being used or located on their current landings, **and clarification as to whether there were more than this** was neither obtained or given.
- A **complete inventory** on all guy extensions and removal of those not meeting required standards may have prevented a second occurrence of this type of incident.
